Design errors in nuclear power plant

Taylor, J.R.

Publication date:
1974

DESIGN ERRORS IN NUCLEAR POWER PLANT

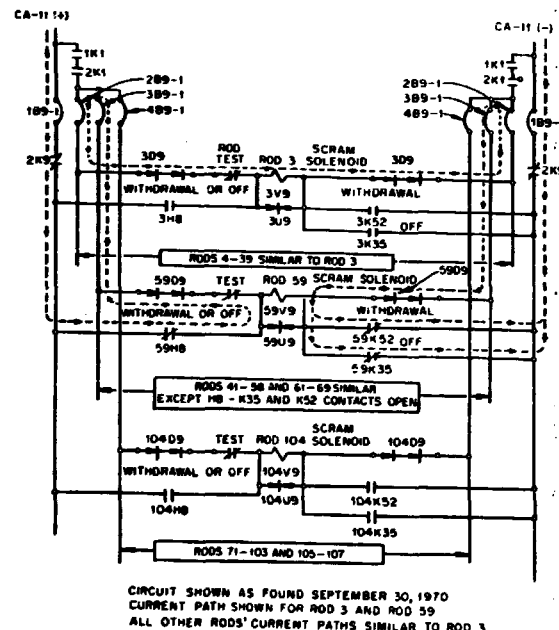
Fig. 2 Rod-scram solenoid circuit and failure path.

The primary scram system of the N reactor failed to operate on signal because of undetected failures of diodes in the scram circuit. The reactor was shut down promptly, however, by the backup ball safety system. The reliability of the primary scram system was improved, after the fact, by the addition of an administratively controlled switch in the main circuit.

review indicated that a possible electrical path for connection of the circuits could be developed by the combination of four diodes failing in the shorted mode in the electrical circuit of a rod, along with that rod's assignment switch being in the Withdrawal or Off position. Rod No. 59 became the prime suspect because it was the only rod in the Off position. Figure 2 also shows the current path from the auxiliary circuit through rods 59 and 3. All other rod solenoids would be similarly energized owing to the parallel-wiring characteristics of the circuit. A visual inspection showed that the No. 59 rod diode quad package was cracked and that a drop of solder protruded through

the crack midway up the canister. Although the four diodes in a rod circuit are electrically connected as shown, they are physically situated in a plug-in canister called a diode quad package that closely resembles a metallic vacuum tube.

Electrical measurements taken across the V9 scram solenoids gave voltage measurements in the range 65 to 95 V, with the highest voltage (95 V) being across 59V9, the rod No. 59 scram solenoid. A current measurement gave about 10 A flowing through the 1B9-1 breaker (breaker trip setting, 12.5 A). Further
